# Experimental study on durability of strengthened corroded RC columns with FRP sheets in tidal zone of marine environment

**Abstract.** The main objective of this paper was to illuminate the effect of marine environmental condition on durability of reinforced concrete (RC)-corroded columns strengthened with carbon fiber reinforced polymer (CFRP) and glass fiber reinforced polymer (GFRP) layers. Small-scale columns were prepared and corroded by an accelerated corrosion process. After strengthening, compressive strength tests were carried out on control and weathered specimens. In this research, a marine simulator was designed and constructed similar to the tidal zone of marine environment in south of Iran which was selected as a case study in this research. Mechanical properties of wrapped specimens were studied after placing them inside the simulator for 3000 hours. Marine environment decreased ultimate strength by 4.5% and 26.3% in CFRP and GFRP-wrapped columns, respectively. In some corroded-columns, strengthening was carried out after replacing damaged cover by self-compacted mortar. In this method, by confining with one layer of CFRP and GFRP, 4.2% and 22.4% reduction in ulti

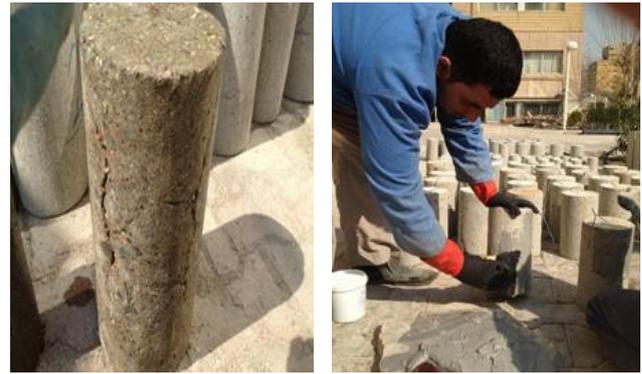
Fig. 3 Preparing specimens for strengthening in method 1

(a) Cleaned specimens (b) Applying primer

The procedure of preparing corroded columns before wrapping in method 1 is shown in Fig. 3. In this method, corroded surface was polished and cleaned, then primer was applied on cracked surface for smoothening.

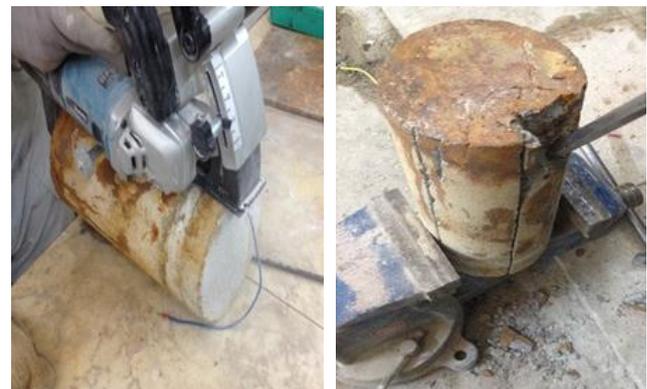
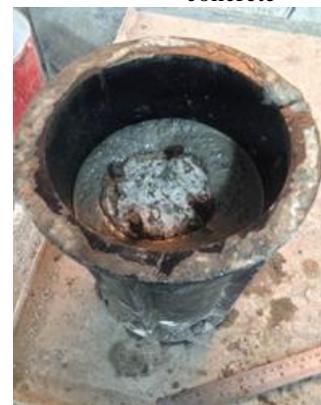
Fig. 4 Preparing specimens for strengthening in method 2

(a) Cutting corroded concrete (b) Removing corroded concrete

(c) Replacing corroded concrete by self-compacted mortar

Fig. 4 shows preparing specimens before confining in method 2. In this method, first the corroded surface was cut to the level of steel bars and then it was removed and replaced with self-compacted mortar. Cutting corroded cover before removing caused less destructive effect on sound concrete.

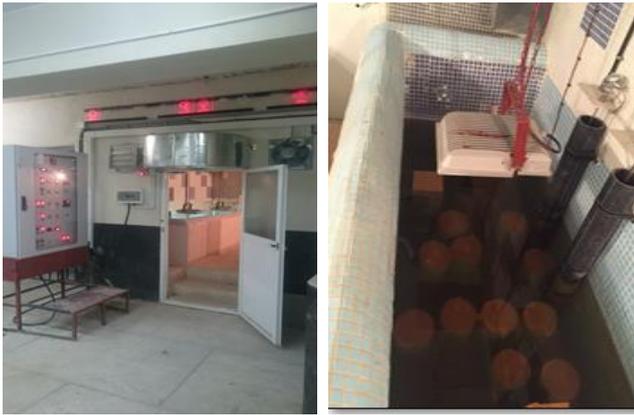
Fig. 5 Marine simulator

(a) Exterior view of the marine simulator (b) Specimens placed in tidal pool

Investigation on the durability of confined RC columns would take a very long time; therefore a marine simulator was constructed in the Concrete Technology and Durability Research Center (CTDRC) at Amirkabir University of Technology to apply accelerated marine condition on the specimens. The simulator was designed to allow researchers to control and monitor the air temperature and humidity, and water temperature, and programming tidal and UV radiation cycles.

The exterior view of the simulator and also the specimens which were placed in the tidal pool are shown in Fig. 5. In order to simulate the coastal region in the south of Iran, the temperature of the interior simulator was set to 40°C, its humidity to 68%, and the salt concentration of water to 36.6 grams per liter. Also, the temperature and humidity of the normal condition in laboratory was 20°C and 40%, respectively. The specimens were placed in the simulator environment for 3,000 hours and experienced 125 cycles of 24 hour. One cycle consisted of 12 hours Immersion in salt water (when the tidal pool was full of salt water) and 12 hours exposure to UV radiation under dry condition (when the tidal pool was empty).

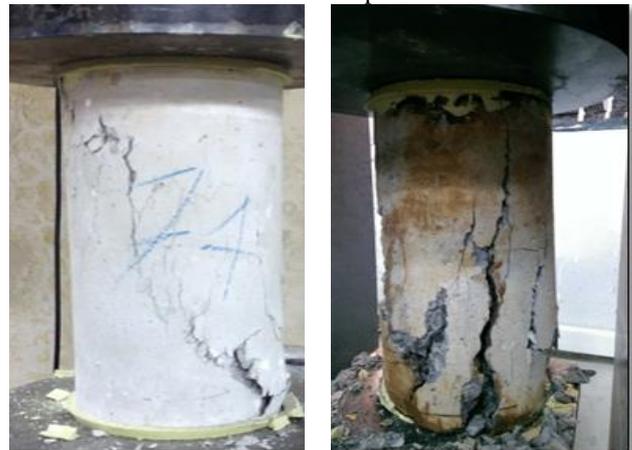
Fig. 7 Effect of accelerated corrosion

(a) Axial stress-strain curves of non-corroded and corroded RC columns before exposure

(b) Failure mode of non-corroded RC columns (c) Failure mode of corroded RC columns

By comparing the axial stress-strain curves for non-corroded (C-C) and corroded RC columns (CA-C), it was found that the ultimate strength, ultimate strain and the modulus of elasticity were decreased by 29%, 14.5% and 22.1%, respectively, after accelerated corrosion process. Degradation in mechanical properties was due to the corrosion of steel bars and consequently propagation of the internal cracks. Fig. 7(a) shows axial stress-strain diagram of non-corroded and corroded RC columns before exposure. Also failure modes of C-C and CA-C columns are shown in Figs. 7(b) and 7(c), respectively. Failure mode of corrosion damaged RC columns was more brittle than non-corroded RC column.

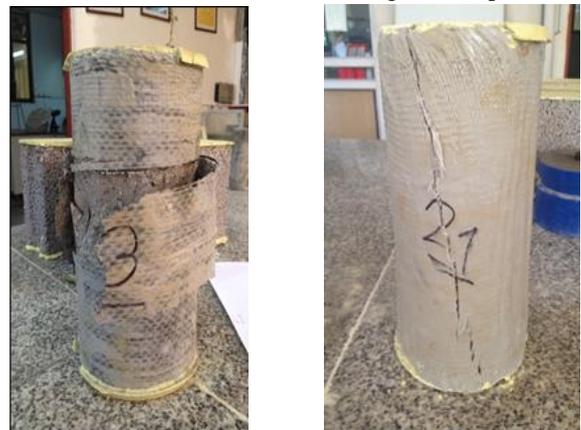
Fig. 9 Effect of retrofit method 2

(a) Axial stress-strain curves of strengthened specimens

(b) Failure mode of CCAR-M(c) Failure mode of CGAR-M

Fig. 9(a) shows axial stress-strain curves for retrofitted specimens after replacing corroded cover by self-compacted mortar (method 2). Parameters obtained from these graphs are summarized in Table 6. Generally, brittle behavior was observed after replacing damaged cover. Probably, this behavior was because of brittle behavior of mortar under compression. Test results in control specimens showed 108% and 152% increase in ultimate strength and 43.5% and 70.4% increase in ultimate strain, after strengthening with one layer of GFRP and CFRP, respectively.

The failure modes of columns retrofitted by method 2, after marine exposure, are shown in Figs. 9(b) and 9(c). Similar to strengthening by method 1, CFRP-wrapped columns were ruptured mainly due to the matrix degradation. Also, fibers degradation was more evident in GFRP-wrapped columns.
